AIRCRAFT ACCIDENT REPORT

**ALOHA AIRLINES, FLIGHT 243
BOEING 737-200, N73711,
NEAR MAUI, HAWAII
APRIL 28, 1988**

NTSB/AAR-89/03

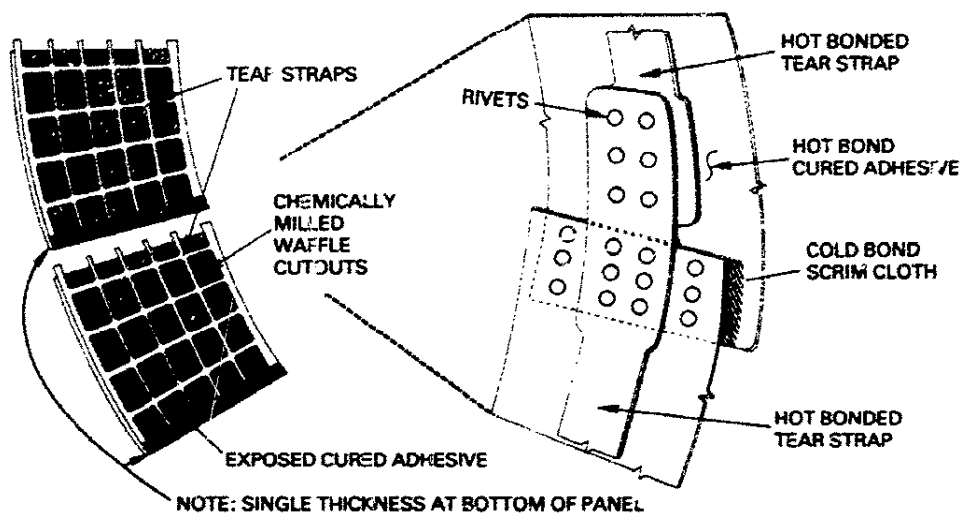
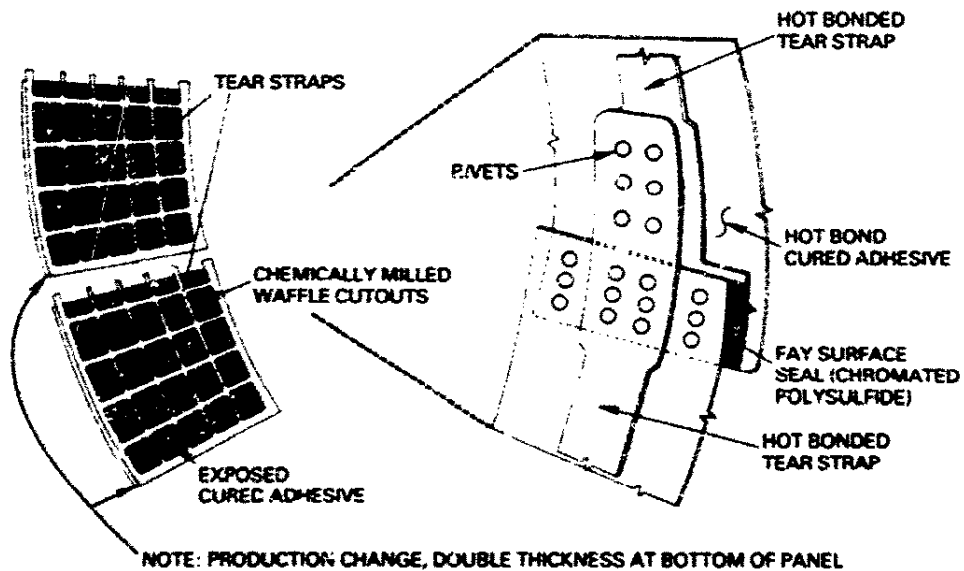
Figure 3.--B-737 Lap splice configuration

The cold bonding process was intended to provide structural efficiency and manufacturing cost advantages plus overall airplane weight reduction over traditionally riveted thick skin panels. Fuselage hoop loads (circumferential pressurization loads) were intended to be transferred through the bonded joint, rather than through the rivets, allowing the use of lighter, thinner fuselage skin panels with no degradation in fatigue life.

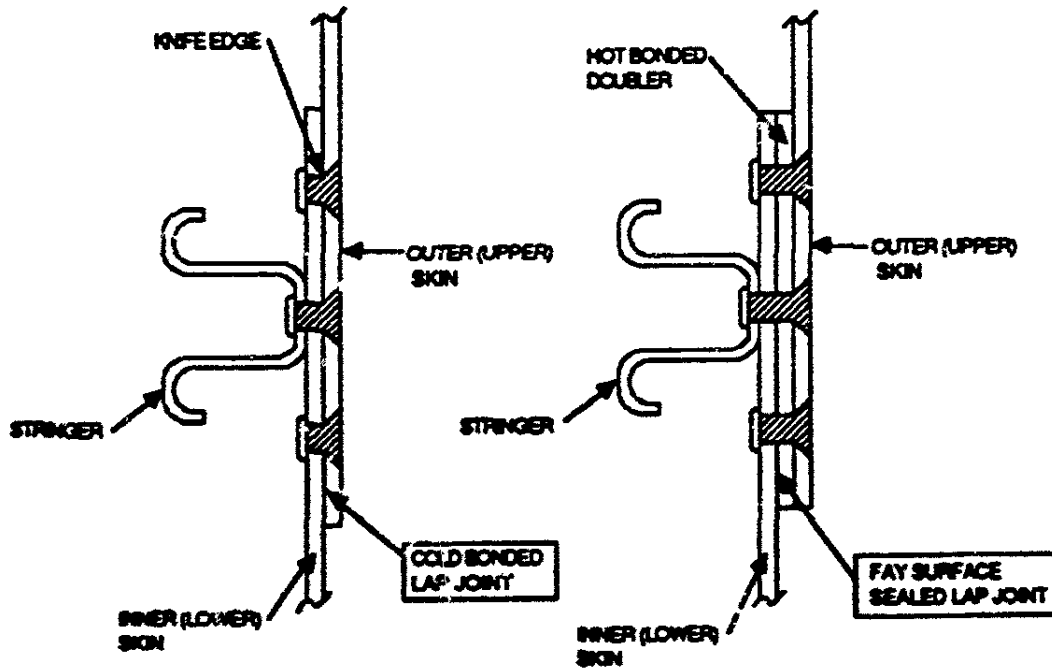
Figure 4a.--Lap joint section between tearstraps

NOTE: SKIN THICKNESS DIMENSION 0.036 in.

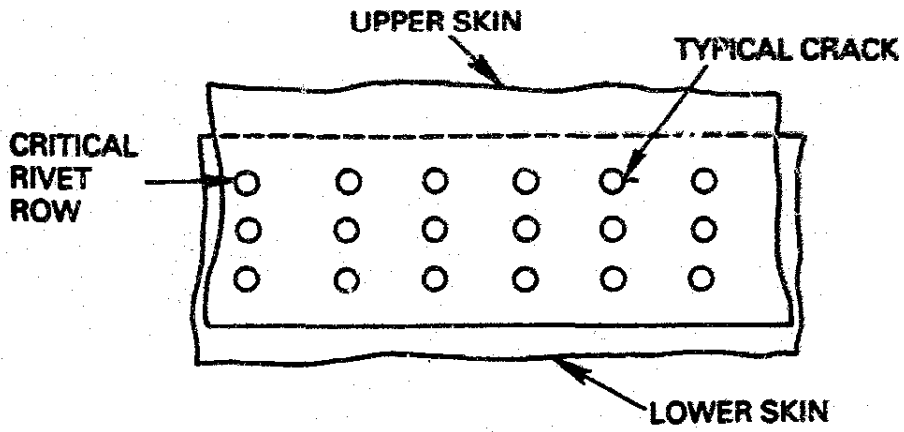
Figure 6a.--Typical lap joint

initially is expected to occur in the outer layer of skin along the lap joint because the outer layer contains a knife edge at each of the countersunk rivet holes. Furthermore, the fatigue cracking primarily is found in the upper row of the outer skin panel lap joint rivet holes because this area carries the greatest stress. For the underlying skin of the lap joint, the area of greatest stress is through the lower row of lap joint rivet holes. However, since the rivet holes in this skin panel are not countersunk, fatigue cracking is not as likely to initiate at this location.

The lap joint piece, S-4L, from BS 519 to BS 536, exhibited fatigue cracking from 16 consecutive rivet holes along the upper row of lap joint rivets. The largest single fatigue crack in one direction measured 0.18 inch from the knife edge of the countersink. (See figure 6.) The longest total combined crack length in both directions across a rivet hole (end to end of the crack including the hole) measured 0.53 inch. Both the cold-bonded lap joint and the hot-bonded tear straps in this area had disbanded. Light to moderate corrosion was present on the previously bonded surfaces.
